Home Inspection Report

1438 Plaza Pl
Wentzville, MO 63385

Inspected By: John Hunt ASHI Certified #
266271

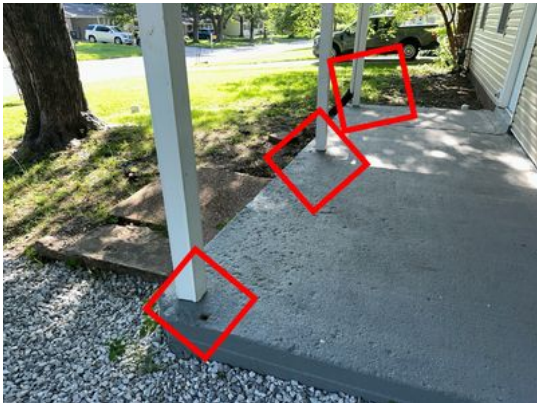
Exterior: 2.4 Porch, Fencing, Sheds, Decks and Exterior Stairway:

We observed wood columns do not have posts brackets and are in contact with wood. This may cause the wood to absorb water rapidly and deteriorate. Recommend repairs by a general contractor.

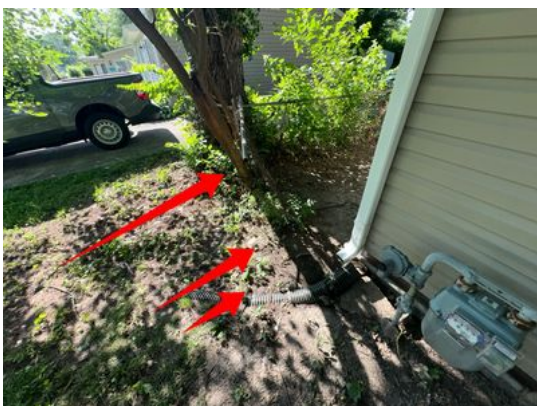
Exterior: 2.4 Porch, Fencing, Sheds, Decks and Exterior Stairway:

We observed at the side of the home the fencing is damaged. Recommend repairs by a qualified contractor.

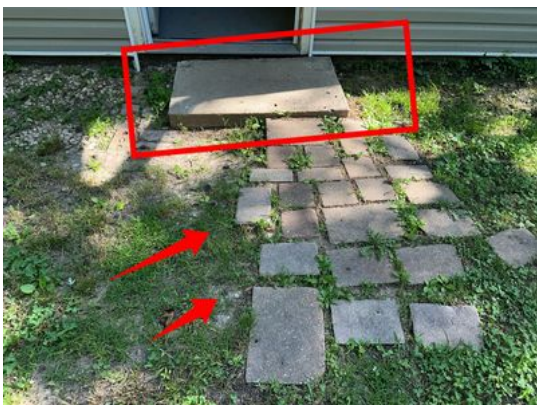
Exterior: 2.5 Vegetation, Grading, Drainage, Driveways, Patio Floor, Walkways and Retaining Walls):

We observed this walkway and step is a trip hazard. Recommend repairs by a qualified contractor.

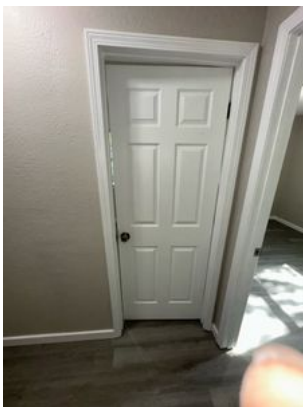
Interior: 4.0 Ceiling, Doors, Floors, and Walls:

We observed the bedroom door is installed improperly. Recommend repairs by a qualified contractor.

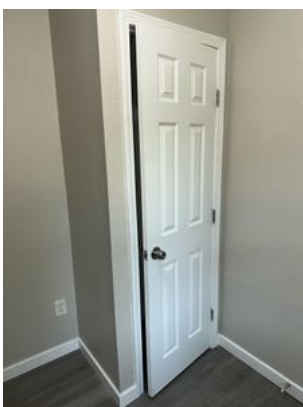
Interior: 4.0 Ceiling, Doors, Floors, and Walls:

We observed in the middle bedroom this closet door is jammed. Recommend repairs by a qualified contractor.

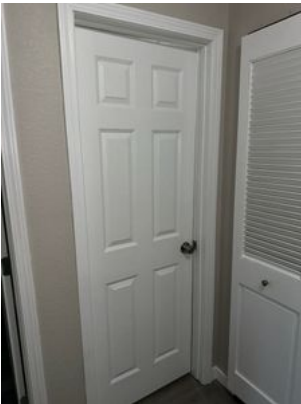
Interior: 4.0 Ceiling, Doors, Floors, and Walls:

We observed the bathroom door is improperly installed. Recommend repairs by a qualified contractor.

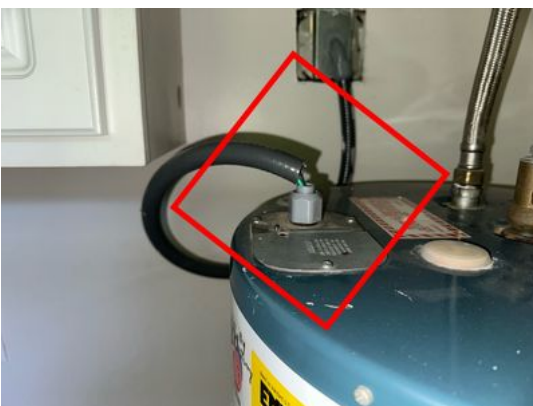
Electrical: 6.0 General Electrical System Conditions, Panels and Meters

We observed the electrical water heater electrical conduit is damaged. The unit may not be properly grounded. Recommend evaluation by an electrical contractor.

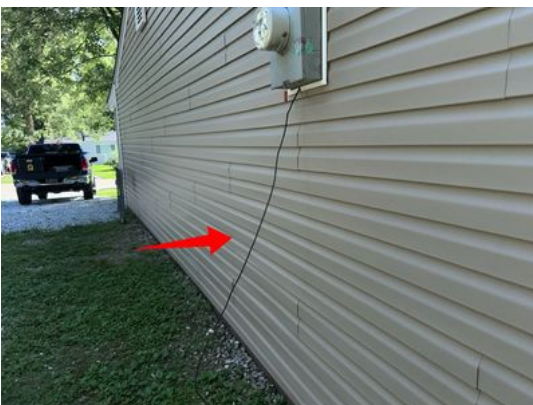
Electrical: 6.5 Grounding Electrical Conductors:

We observed the grounding electrical conductor is not properly secured. Recommend repairs by an electrical contractor.

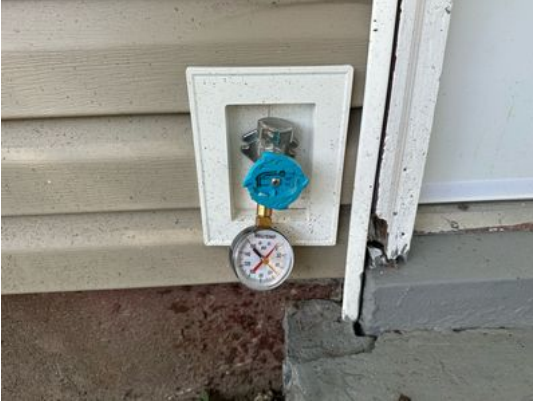
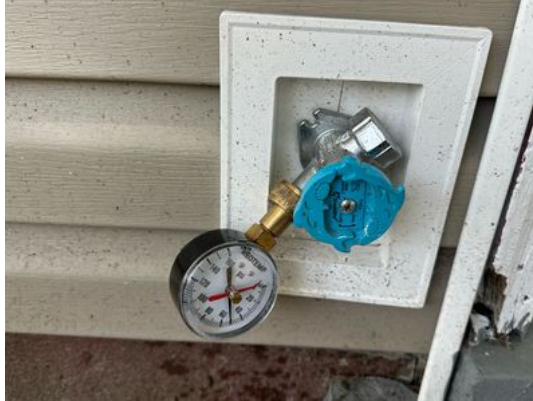
Plumbing: 7.0 Plumbing Water Supply, Distribution System And Drain Fixtures:

We observed at the front of the home the water spigot is not properly secured. Recommend repairs by a plumbing contractor.

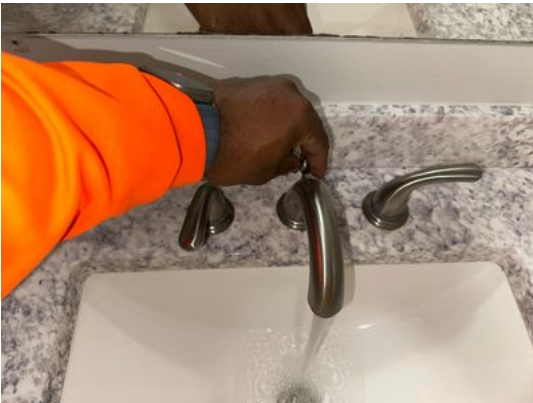
Plumbing: 7.0 Plumbing Water Supply, Distribution System And Drain Fixtures:

During our inspection of the hallway bathroom, we have observed that the mechanical stop, which allows the sink to be filled with water, is either missing or broken. This can lead to difficulties in using the sink and may result in water wastage.

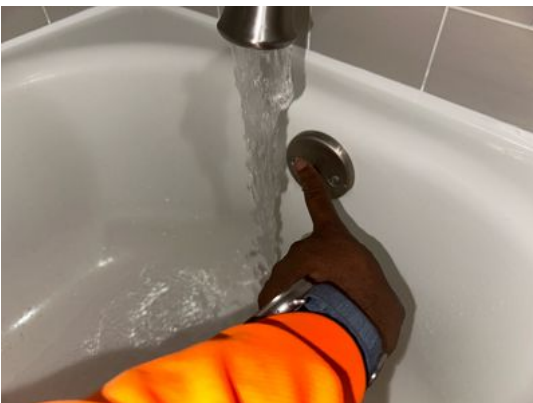
Plumbing: 7.0 Plumbing Water Supply, Distribution System And Drain Fixtures:

We observed in the bathtub, the mechanical stop is not properly installed. This may hinder your ability to fill the tub. Recommend repairs by a plumbing contractor.

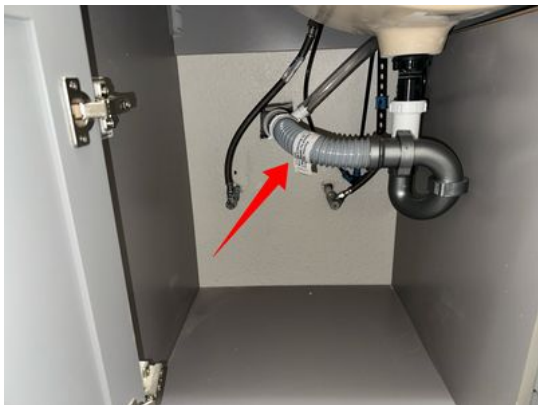
Plumbing: 7.1 Plumbing Drain, Waste And Vent Systems:

Based on our observation, we noticed that in the bathroom, there is a plastic flex plumbing drain. It is important to note that this type of drain may allow debris buildup and potentially lead to clogging issues. Recommend repairs by a plumbing contractor.

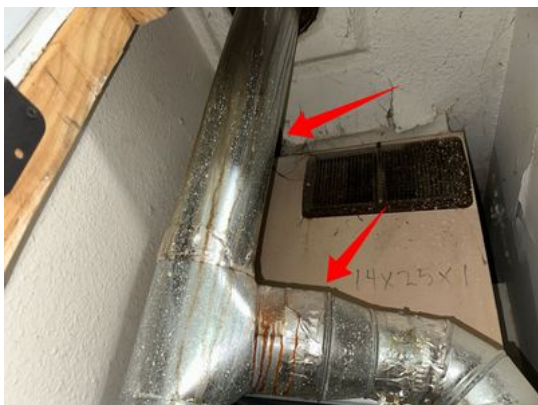
Heating/Central Air Conditioning: 8.3 Flues and Vents (for gas water heater or heat systems)

We observed the exhaust flue has prior signs of water penetration. Recommend evaluation by a qualified contractor.

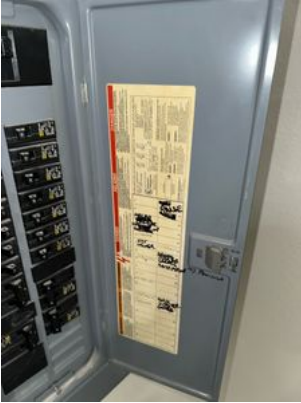
Electrical: 6.0 General Electrical System Conditions, Panels and Meters

During our inspection of the electrical panel, we have observed that the ledger, which labels each breaker, is not sufficiently done. It is important to have clear and accurate labeling for each breaker, indicating the corresponding appliance or device on the circuit. This helps in identifying and troubleshooting electrical issues, as well as ensuring the safe operation of the electrical system. Recommend repairs by an electrical contractor.

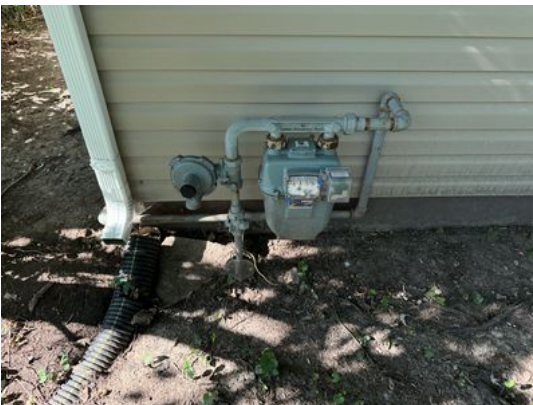
Plumbing: 7.3 Fuel Storage and Distribution Systems

We observed the building has a gas utility. Recommend a gas inspection by a qualified contractor.

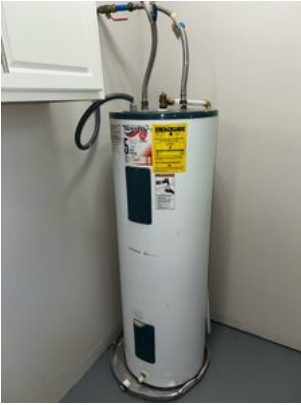
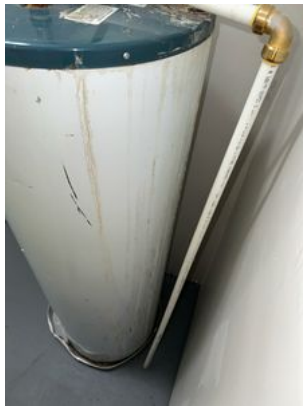
Plumbing: 7.6 Maintenance Schedule (water tank service maint. recommended)

Based on our observation, we noticed that the water tank is working as intended. However, there are no records etc., (maintenance stickers) indicating that the water heater has been receiving annual service maintenance. Recommend annual service maintenance be performed before closing by a plumbing contractor.

Water heater maintenance consists of flushing the unit, checking and changing the anode rod if needed, inspecting for rust or leaks, and testing the thermostat and valves. The flush is the most important step of water heater maintenance, and something you do not want to skip.

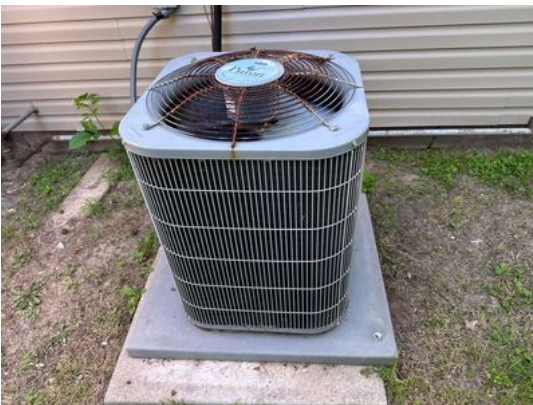
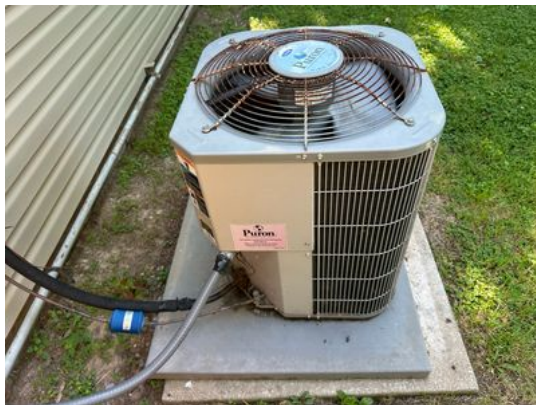
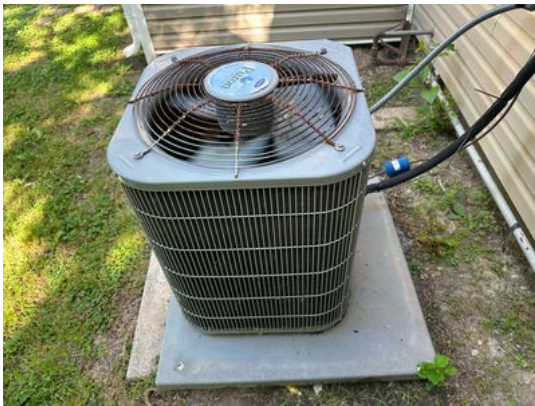
Heating/Central Air Conditioning: 8.5 Cooling and Air Handler Equipment

Based on our observation, we noticed that the AC system is working as intended. However, we did not find any records, etc., (maintenance stickers) indicating whether or not the unit has been receiving annual service maintenance as recommended by the manufacturer. To ensure the optimal performance and longevity of the AC system, we recommend scheduling annual service maintenance by a qualified HVAC technician; before finalizing the purchase of the real estate.

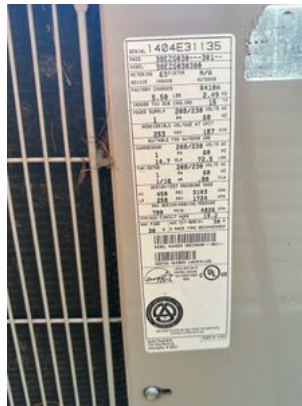
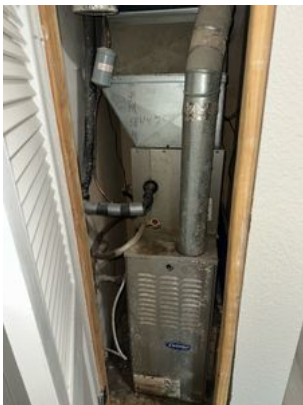
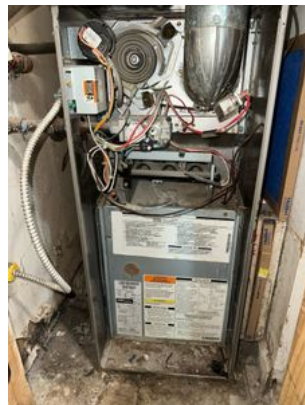
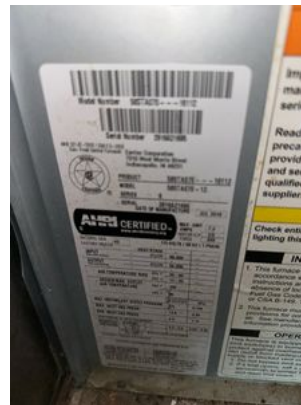
Heating/Central Air Conditioning: 8.6 Maintenance Schedule (HVAC service maint. recommended)

Our observations indicate that the furnace is functioning properly. However, we did not find any maintenance records or stickers to confirm whether the unit has been receiving the recommended annual service maintenance. Additionally, to ensure the home is equipped with the right size HVAC system, we recommend scheduling an annual service maintenance appointment with a qualified HVAC technician before finalizing the property purchase.

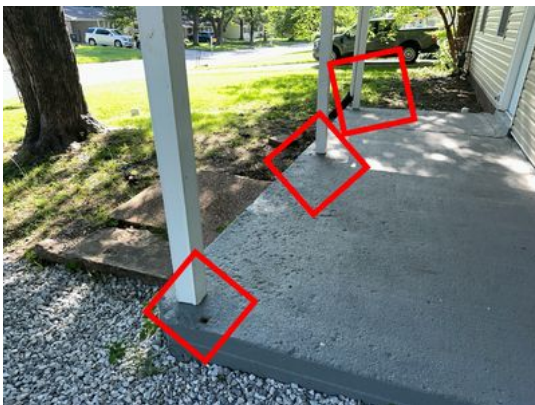
We observed wood columns do not have posts brackets and are in contact with wood. This may cause the wood to absorb water rapidly and deteriorate. Recommend repairs by a general contractor.

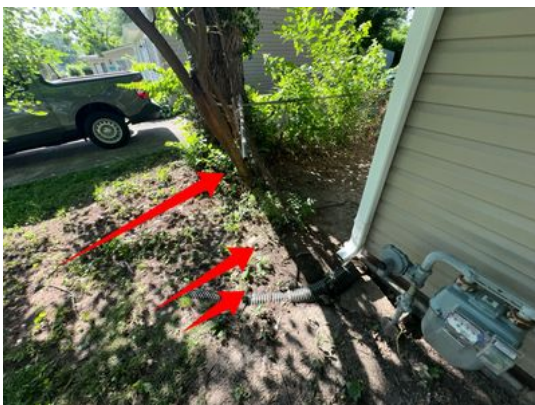
Comment 5

We observed at the side of the home the fencing is damaged. Recommend repairs by a qualified contractor.

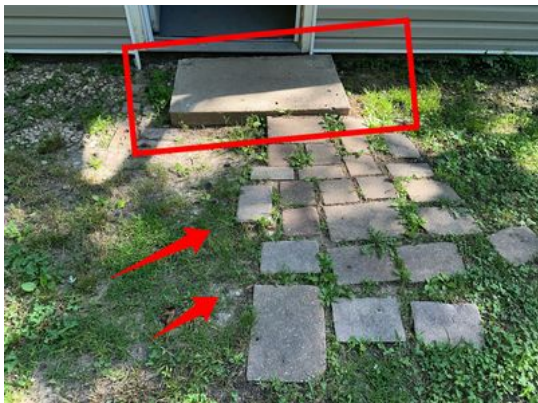
2.5 Vegetation, Grading, Drainage, Driveways, Patio Floor, Walkways and Retaining Walls):

We observed this walkway and step is a trip hazard. Recommend repairs by a qualified contractor.

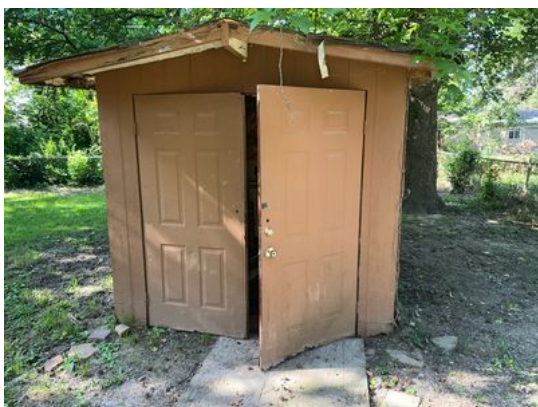
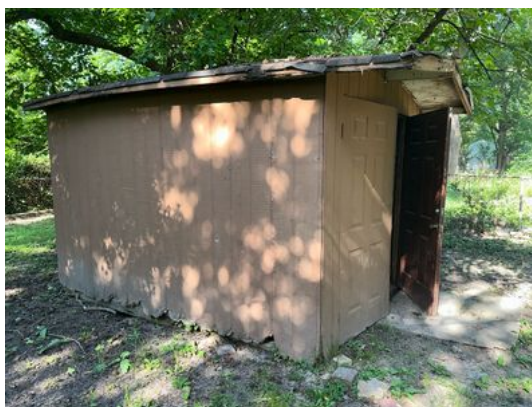
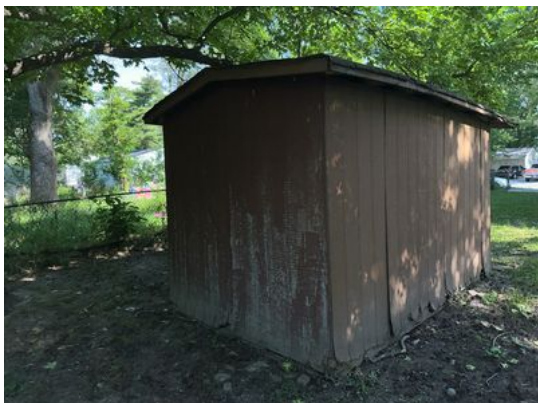
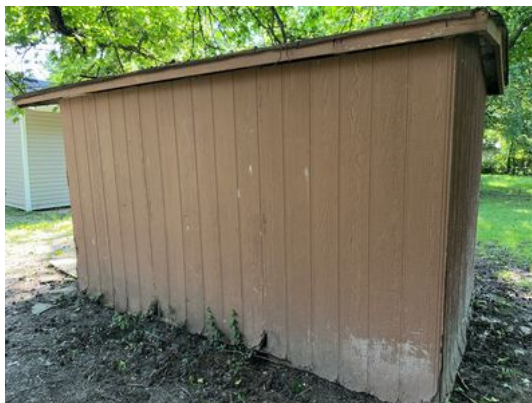
We observed at the rear of the home this shed. This is considered personal property and outside the scope of this inspection.

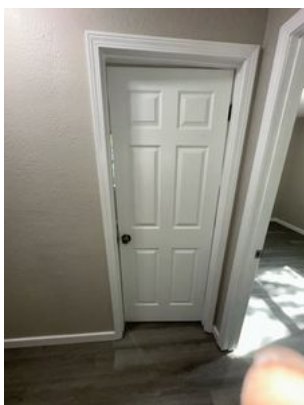
We observed the bedroom door is installed improperly. Recommend repairs by a qualified contractor.

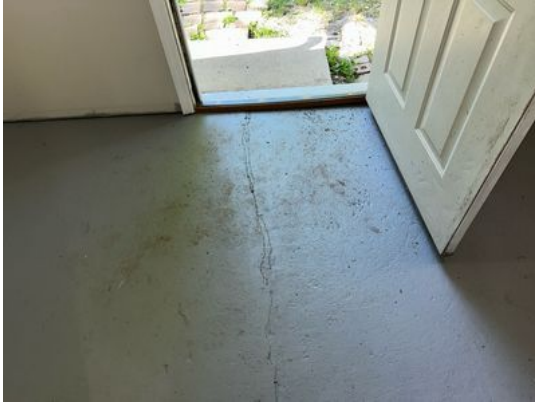
We observed this area may allow water penetration. This may be due to no storm door. Recommend evaluation by a qualified contractor.

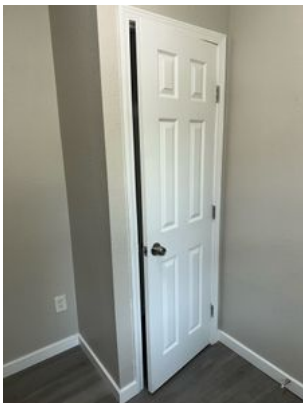
Comment 11

We observed in the middle bedroom this closet door is jammed. Recommend repairs by a qualified contractor.

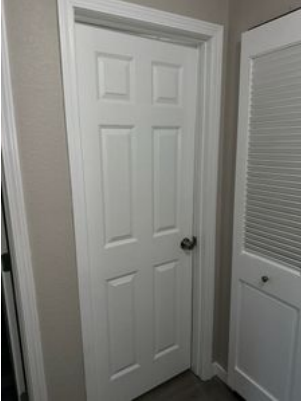
Comment 12

We observed the bathroom door is improperly installed. Recommend repairs by a qualified contractor.

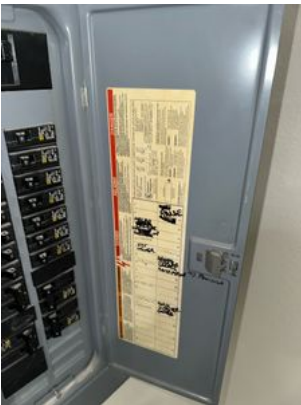
During our inspection of the electrical panel, we have observed that the ledger, which labels each breaker, is not sufficiently done. It is important to have clear and accurate labeling for each breaker, indicating the corresponding appliance or device on the circuit. This helps in identifying and troubleshooting electrical issues, as well as ensuring the safe operation of the electrical system. Recommend repairs by an electrical contractor.

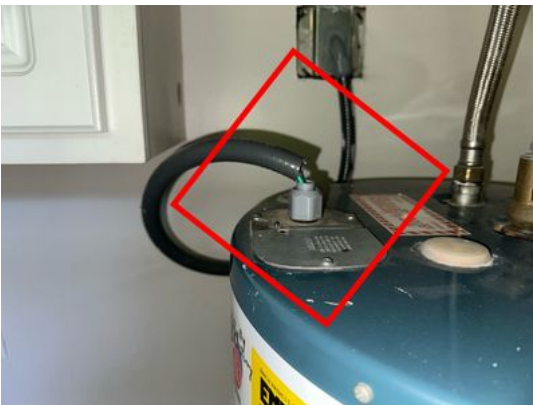
We observed the electrical water heater electrical conduit is damaged. The unit may not be properly grounded. Recommend evaluation by an electrical contractor.

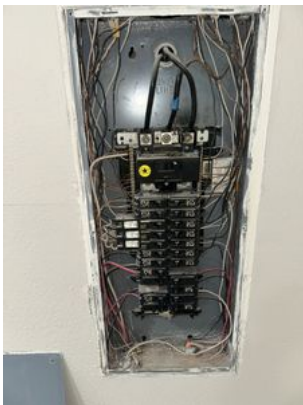
**Comment 15
Information**

We observed no AFCI/GFCI combination breakers in the panel. Recommend upgrading the entire panel with AFCI/GFCI combination breakers by an electrical contractor.

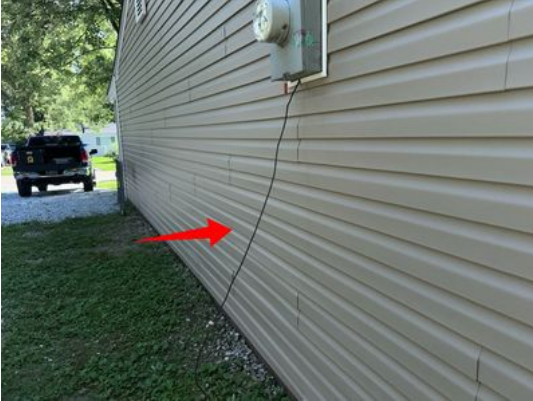
6.5 Grounding Electrical Conductors:

We observed the grounding electrical conductor is not properly secured. Recommend repairs by an electrical contractor.

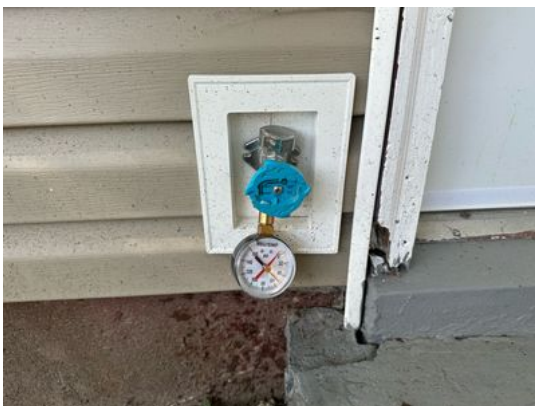
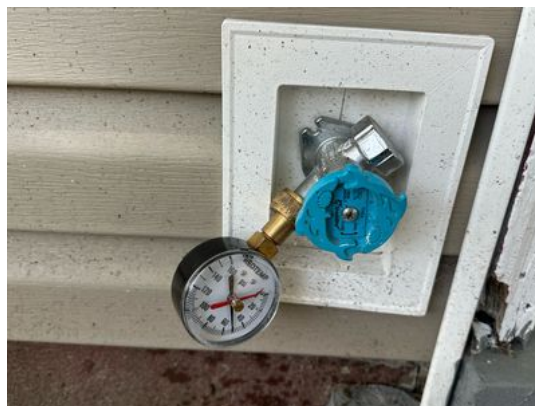
We observed at the front of the home the water spigot is not properly secured. Recommend repairs by a plumbing contractor.

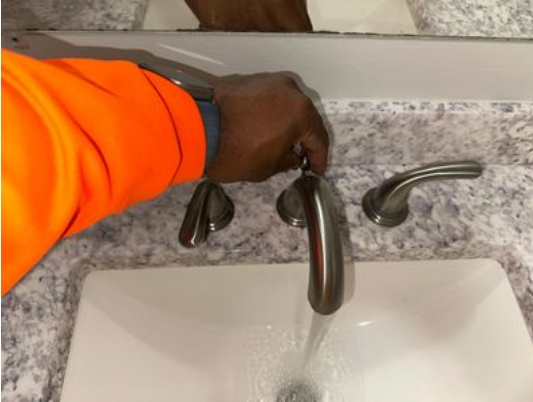
During our inspection of the hallway bathroom, we have observed that the mechanical stop, which allows the sink to be filled with water, is either missing or broken. This can lead to difficulties in using the sink and may result in water wastage.

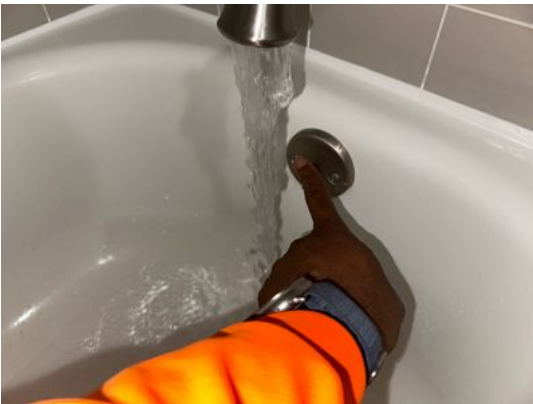
We observed in the bathtub, the mechanical stop is not properly installed. This may hinder your ability to fill the tub. Recommend repairs by a plumbing contractor.

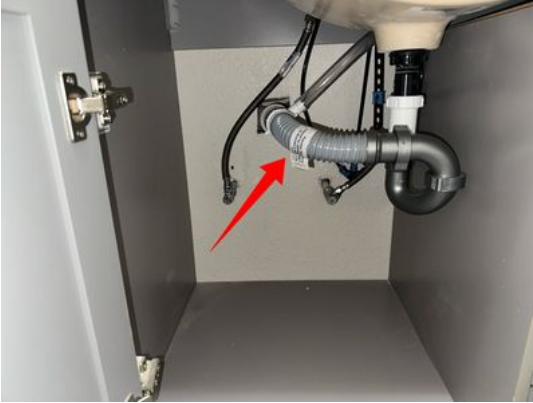
7.1 Plumbing Drain, Waste And Vent Systems:

Based on our observation, we noticed that in the bathroom, there is a plastic flex plumbing drain. It is important to note that this type of drain may allow debris buildup and potentially lead to clogging issues. Recommend repairs by a plumbing contractor.

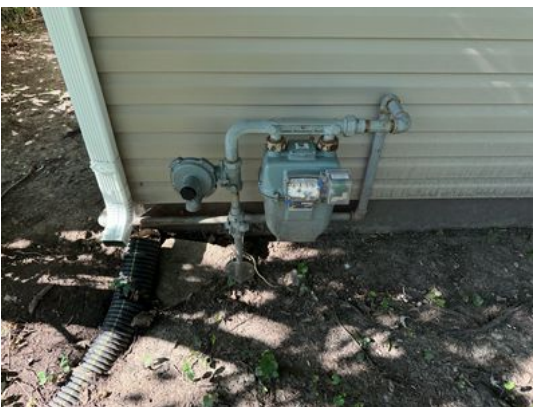
We observed the building has a gas utility. Recommend a gas inspection by a qualified contractor.

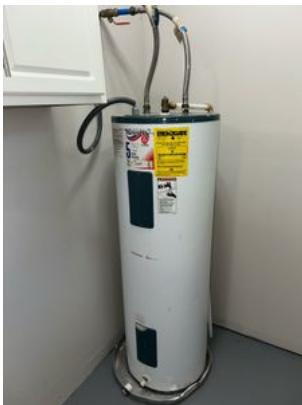
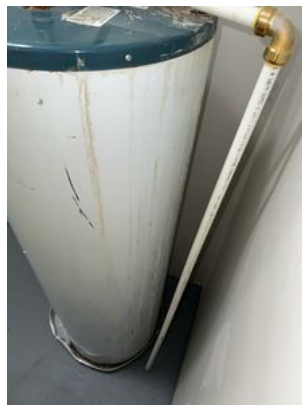
7.6 Maintenance Schedule (water tank service maint. recommended)

Based on our observation, we noticed that the water tank is working as intended. However, there are no records etc., (maintenance stickers) indicating that the water heater has been receiving annual service maintenance. Recommend annual service maintenance be performed before closing by a plumbing contractor.

Water heater maintenance consists of flushing the unit, checking and changing the anode rod if needed, inspecting for rust or leaks, and testing the thermostat and valves. The flush is the most important step of water heater maintenance, and something you do not want to skip.

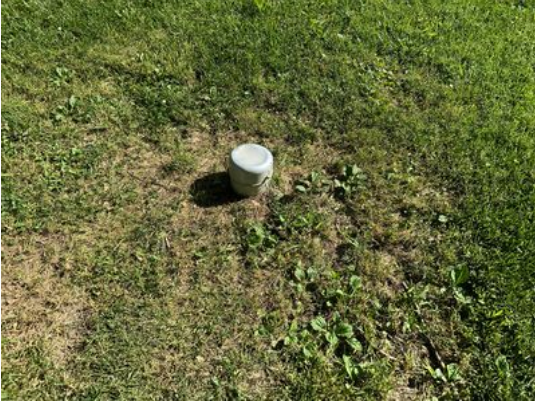
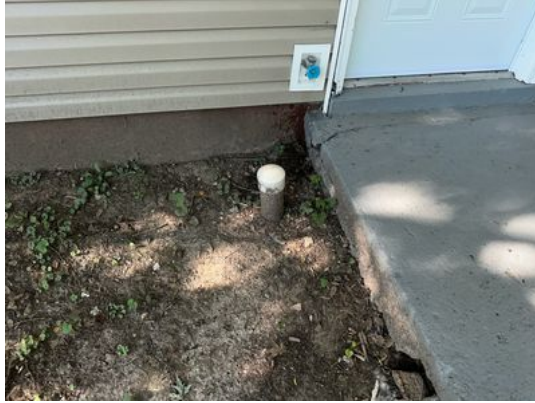
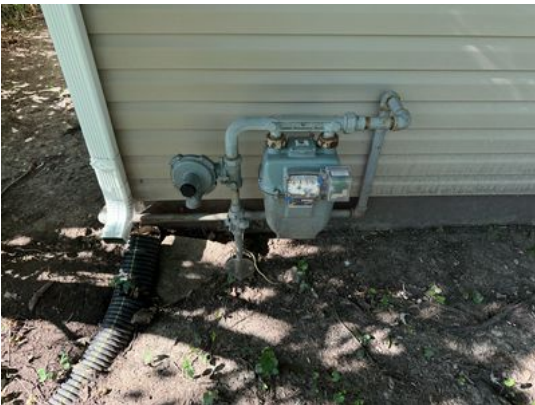
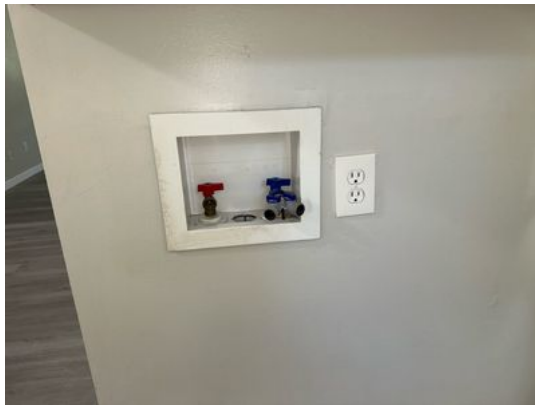
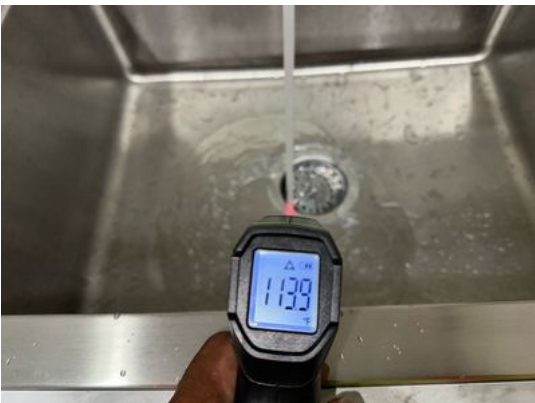
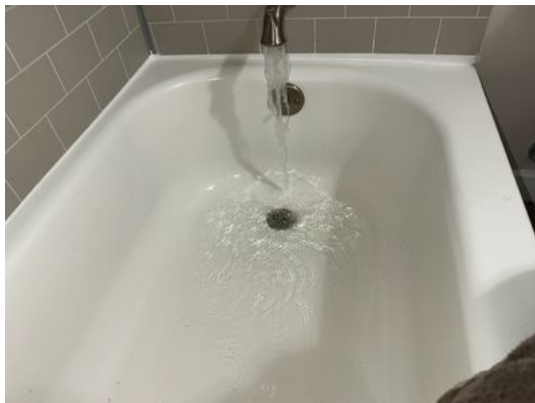
Comment 24 Information

Overview Of Plumbing Photos

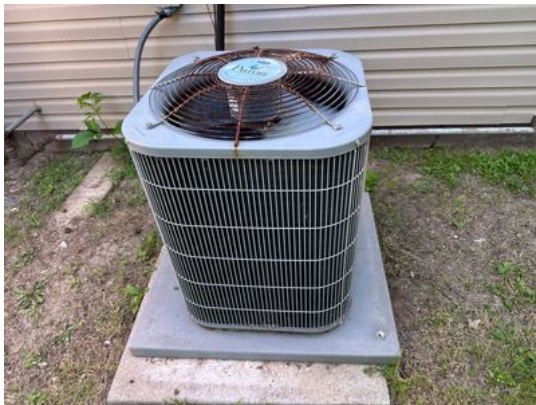
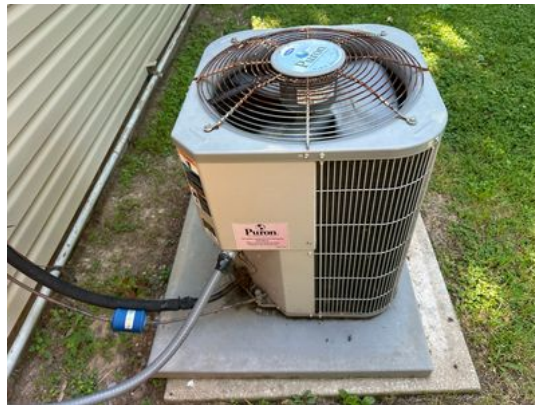
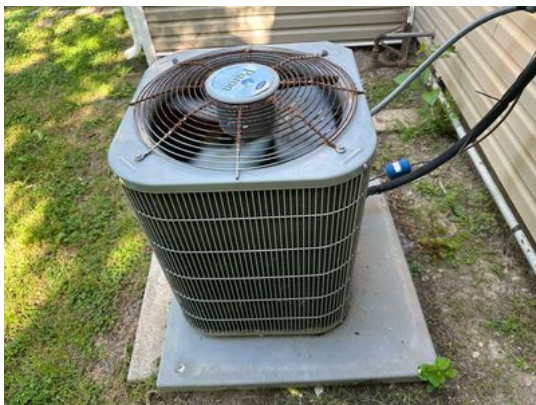
Based on our observation, we noticed that the AC system is working as intended. However, we did not find any records, etc., (maintenance stickers) indicating whether or not the unit has been receiving annual service maintenance as recommended by the manufacturer. To ensure the optimal performance and longevity of the AC system, we recommend scheduling annual service maintenance by a qualified HVAC technician; before finalizing the purchase of the real estate.

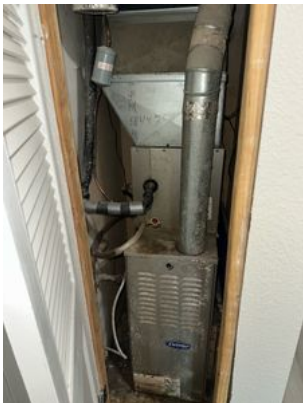
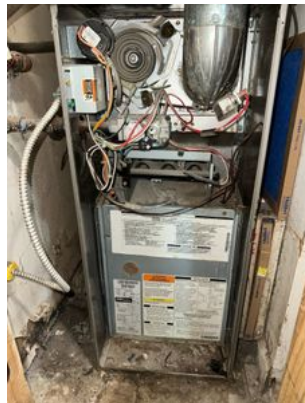
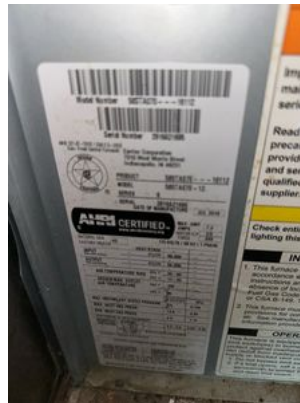
Comment 27
Deferred Maintenance

Our observations indicate that the furnace is functioning properly. However, we did not find any maintenance records or stickers to confirm whether the unit has been receiving the recommended annual service maintenance. Additionally, to ensure the home is equipped with the right size HVAC system, we recommend scheduling an annual service maintenance appointment with a qualified HVAC technician before finalizing the property purchase.

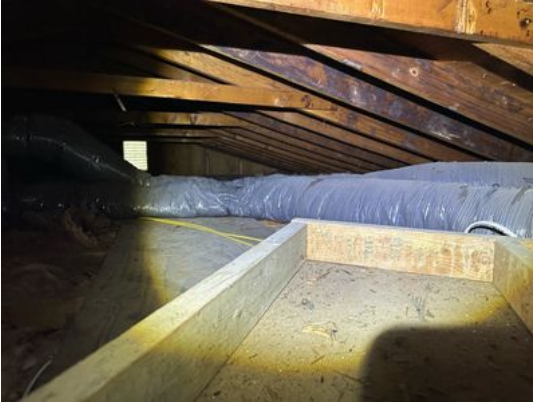
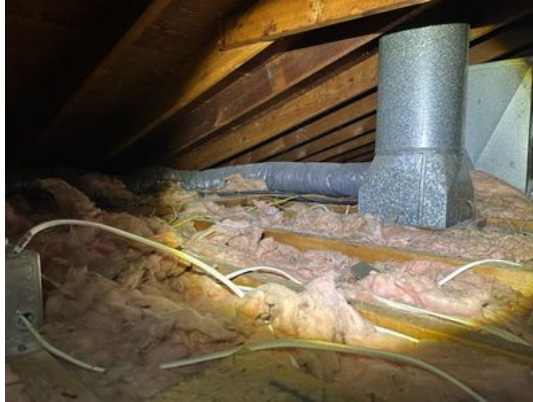
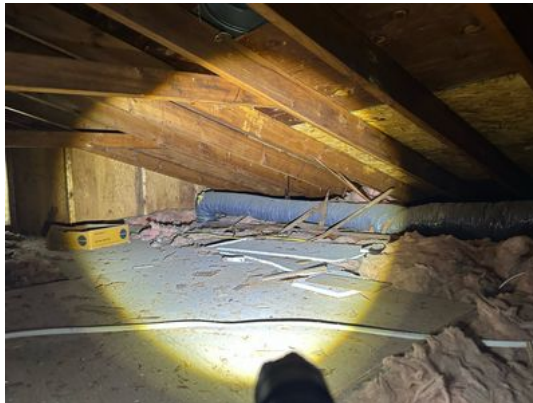
Comment 33
Information

We observed the attic does not have a sufficient amount of insulation. In addition, the insulation in place is compacted. Recommend upgrading by a qualified contractor.
